Geounit ID: <u>5730</u>	Property ID (AD#): <u>AD-000686</u>	Address: <u>875 US Highway 2</u>
----------------------------	--	-------------------------------------

Surveyor(s)/Company: M. Farnham (CDM SMITH) Removal Contractor: PRI-ER

US ARMY CORPS OF ENGINEERS OMAHA DISTRICT RAPID RESPONSE PROGRAM</div>	LIBBY ASBESTOS PROJECT LINCOLN COUNTY, MONTANA	AD #: 000686      GEUNIT #: 5730      GRZ #: 00	DRAWING BY/DATE T. ROBERTSON 03/28/13	REVISION #:	REVISION DATE:	DESCRIPTION:
		LINCOLN COUNTY PORT AUTHORITY  875 US HIGHWAY 2  RESTORATION DESIGN	QC REVIEW BY/DATE K. MCKENZIE 04/03/13	0	04/12/13		
			DRAWING FINALIZED BY/DATE T. ROBERTSON 04/12/13	N/A	N/A	N/A	
				N/A	N/A	N/A	
				N/A	N/A	N/A	
...\\OU4\STREET BY NAME\US HIGHWAY 2\875 US HIGHWAY 2\FISHING POND\CAD\--FINAL DESIGN--REV.0.DWG

Property Address: 875 US Hwy 2 (Fishing Pond)

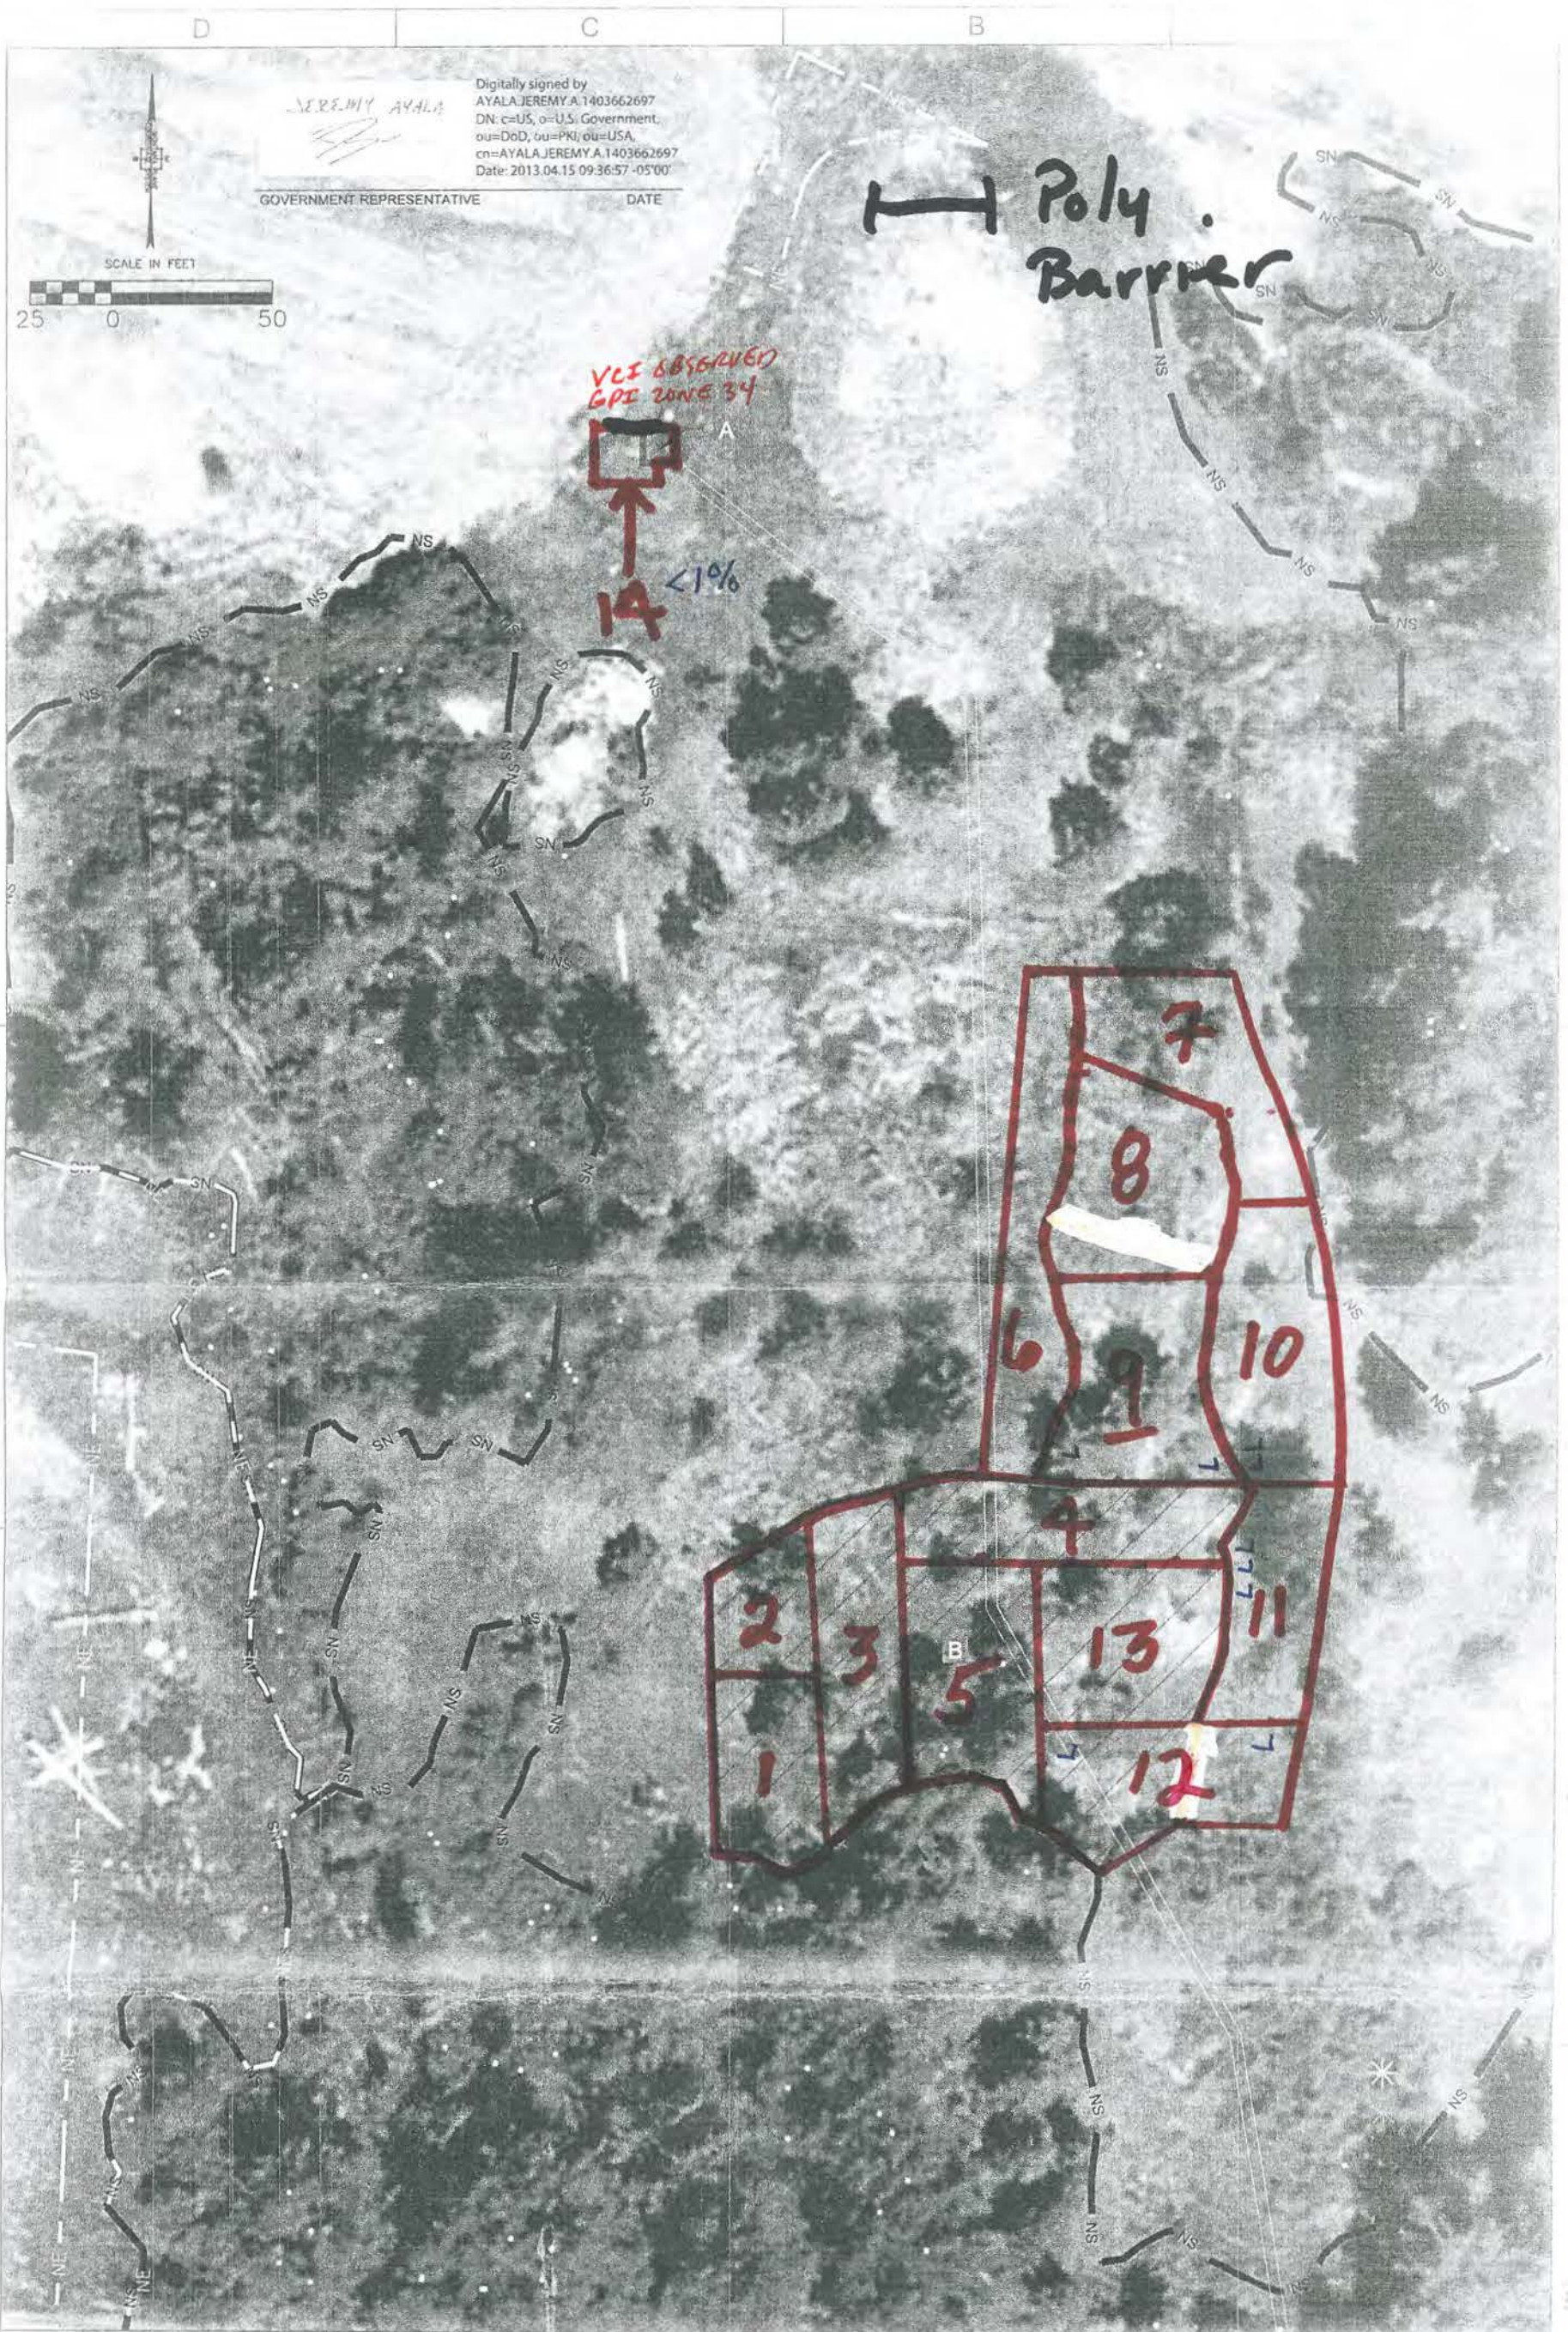
SHEET:  2  OF 2

Comments: Vermiculite was observed on the mound north of area A (in GPI zone 34). USACE instructed not to expand area to include the mound.

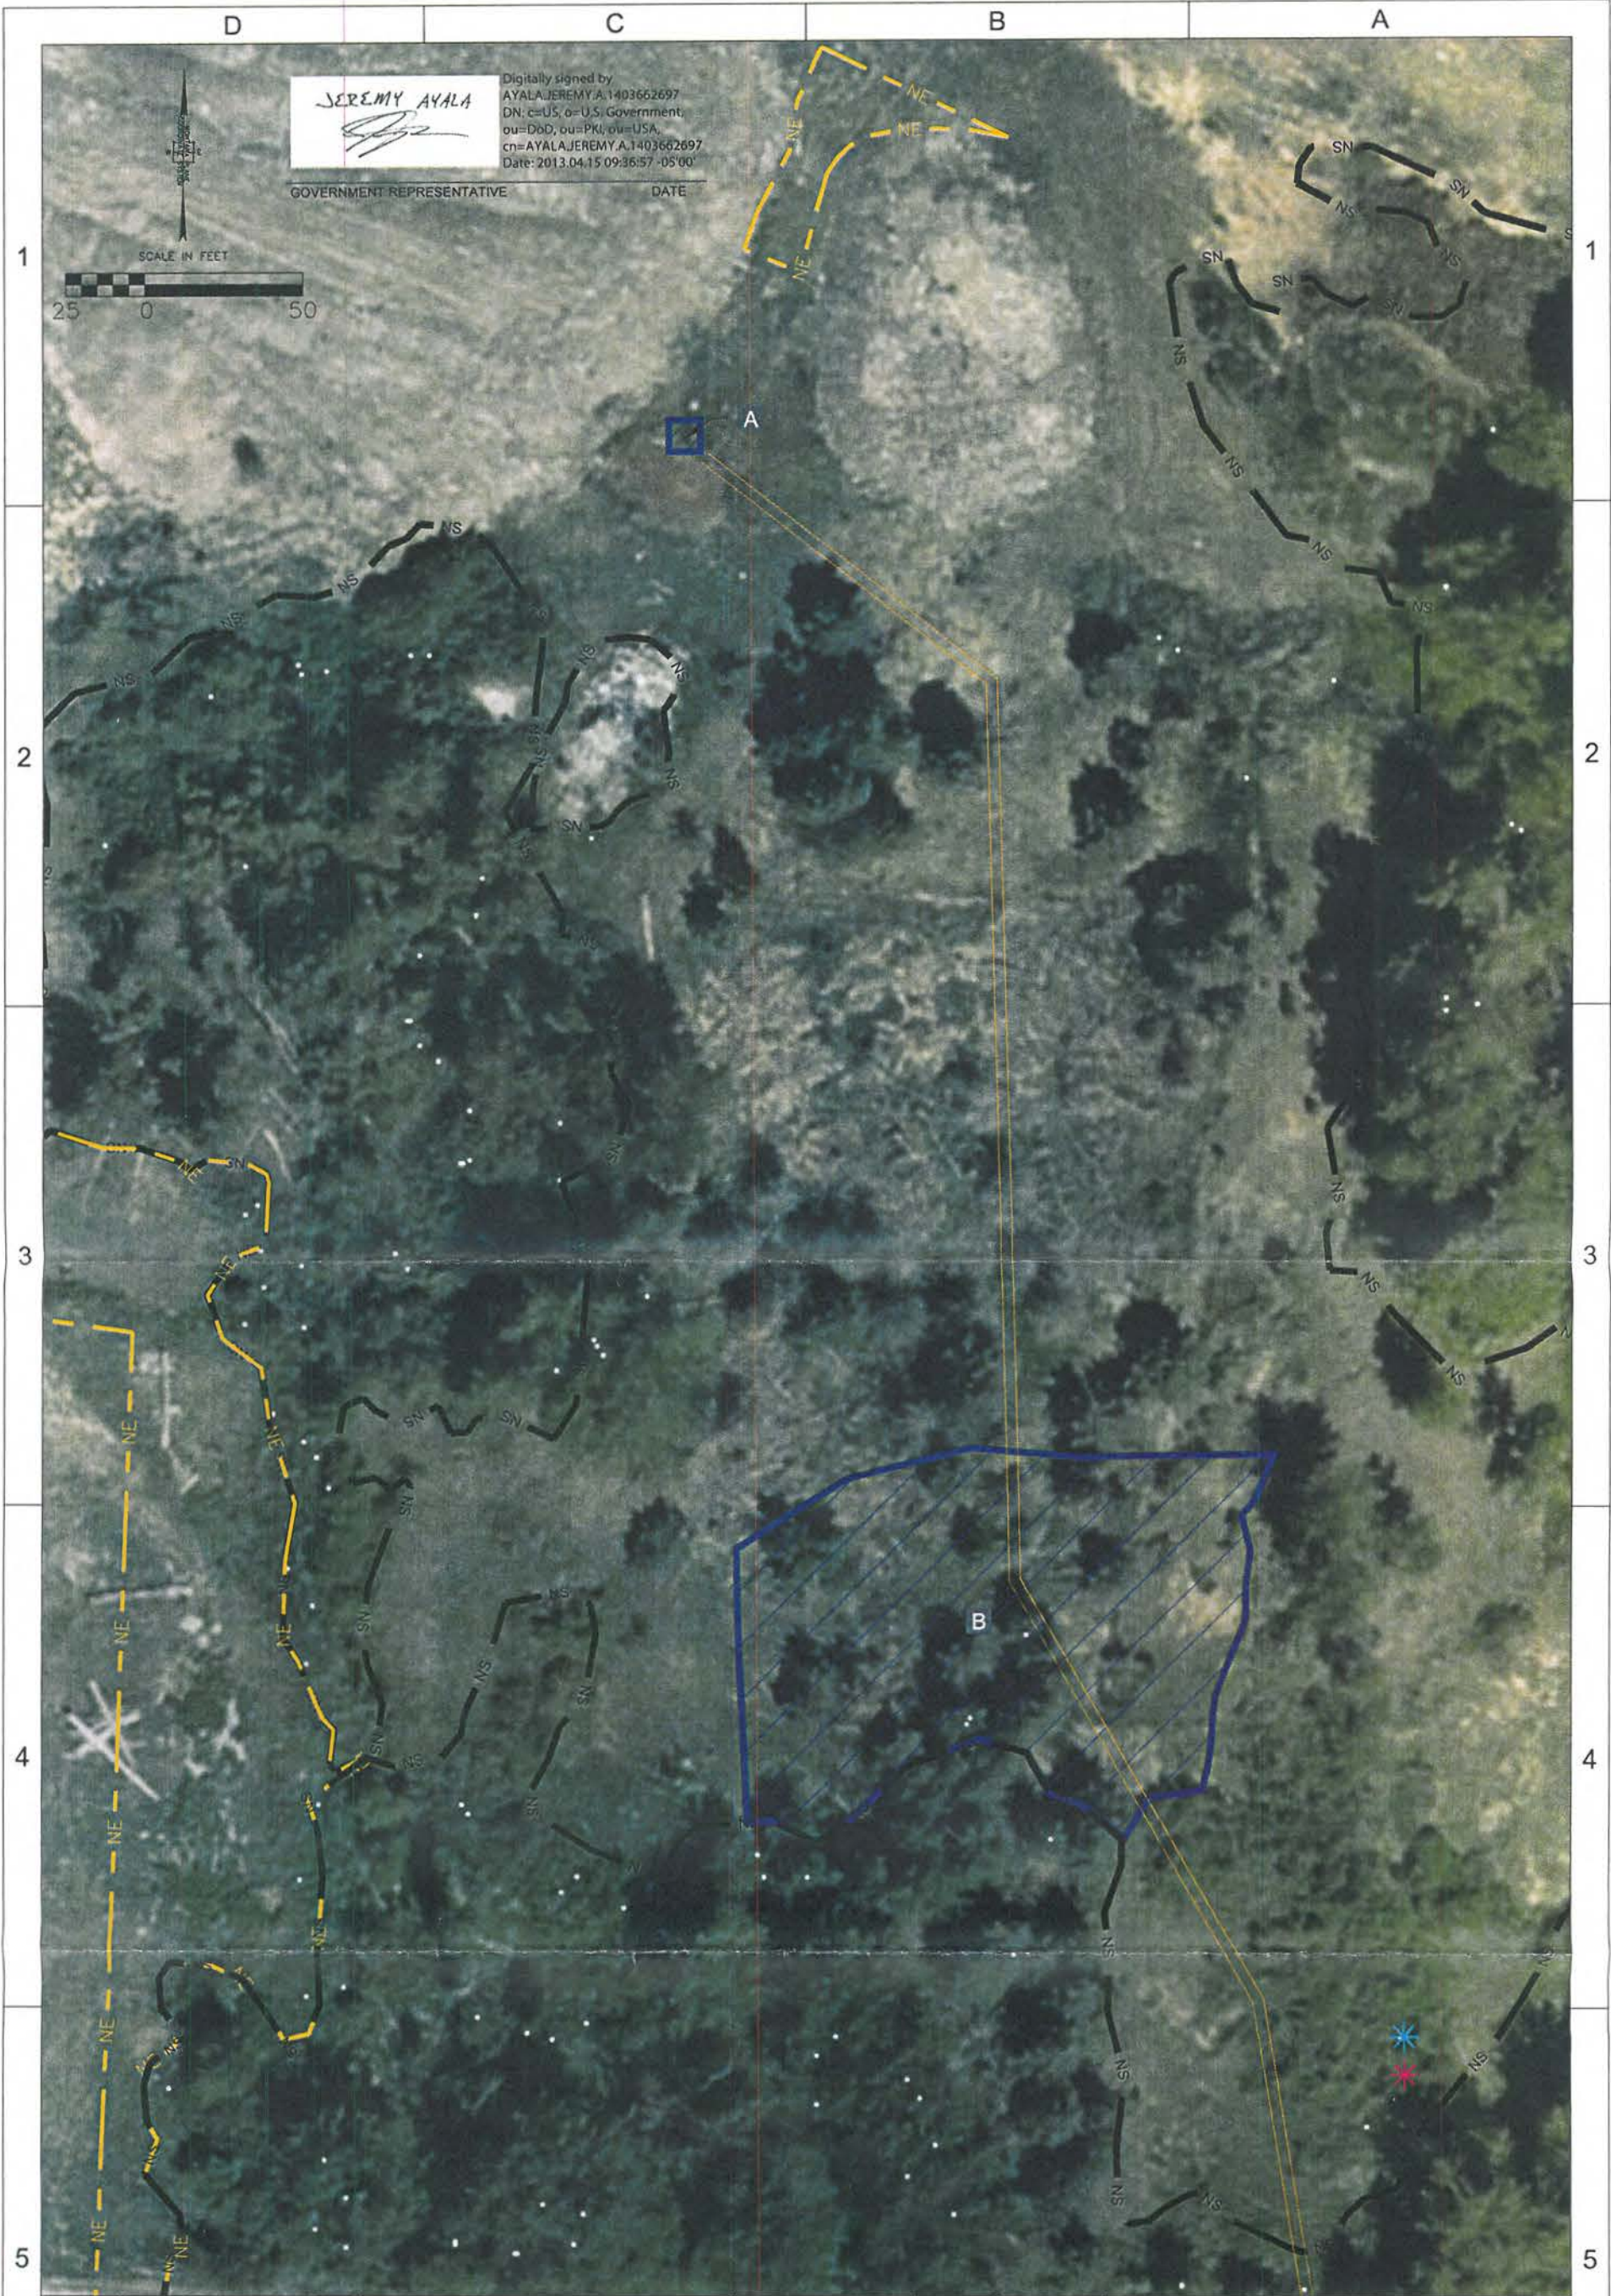
SHEET: 2 OF 2

Pile of building debris.  
No VCI observed.  
No sample taken.

BLACK LINE SHOWS PROPOSED SITE OF  
FISHING POND. THIS LINE DOES NOT  
COMPLETELY MATCH SITE CONDITIONS OF  
THE FLAGGING PUT OUT BY LINCOLN COUNTY

FORMER NUA SAMPLED ON 3-14-13.  
NO VCS OBSERVED. SP-146237, 7-00114 ND
